# Absolute Home Inspection Services

## Home Inspection Report

Property address: **101 Perfect Place  
Anytown, NC**

Inspection date: **Thursday, October 12, 2006**

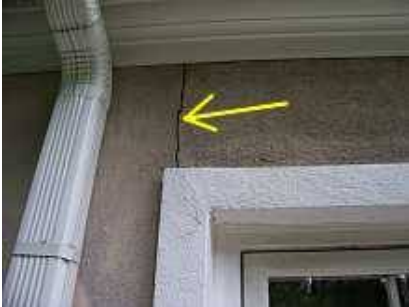
Photo 1-1

Cracks, deterioration and/or damage were found in one or more areas of the expanded foam insulation system (EIFS) siding. A qualified contractor who specializes in this material should evaluate and make repairs as necessary.

- Cracks, deterioration and/or damage were found in one or more areas of the expanded foam insulation system (EIFS) siding. A qualified contractor who specializes in this material should evaluate and make repairs as necessary.

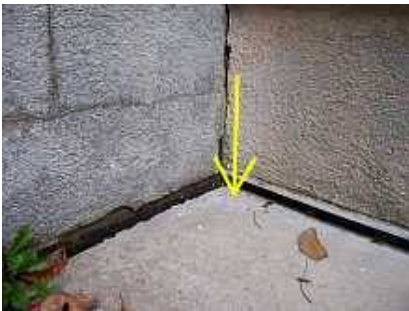
Photo 2-1

The concrete patio on the southwest side of the house has settled approximately 1". Subsequently a gap around the perimeter exist that may allow water to deteriorate the wood structure of the home. A qualified concrete specialist should be consulted for solutions, such as adding a thin layer of concrete, installing pavers or stones to the existing surface, etc.

- The concrete patio on the southwest side of the house has settled approximately 1". Subsequently a gap around the perimeter exist that may allow water to deteriorate the wood structure of the home. A qualified concrete specialist should be consulted for solutions, such as adding a thin layer of concrete, installing pavers or stones to the existing surface, etc.

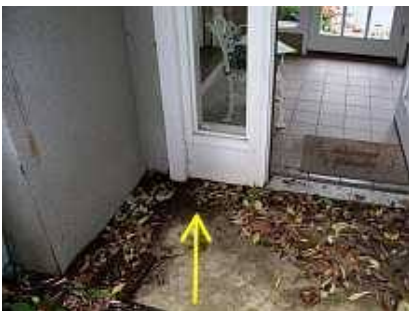
Photo 3-1

The perimeter grading slopes towards the structure in one or more areas. This can result in water accumulating around the structure's foundation, or in basements and crawl spaces if they exist. Accumulated water is a conducive condition to wood destroying insects and organisms. Wet soil may also cause the foundation to settle and possibly fail over time. Recommend grading soil so it slopes down and away from the structure with a slope of at least 5% (10% or better is optimal) for at least 6 feet.

- The perimeter grading slopes towards the structure in one or more areas. This can result in water accumulating around the structure's foundation, or in basements and crawl spaces if they exist. Accumulated water is a conducive condition to wood destroying insects and organisms. Wet soil may also cause the foundation to settle and possibly fail over time. Recommend grading soil so it slopes down and away from the structure with a slope of at least 5% (10% or better is optimal) for at least 6 feet.

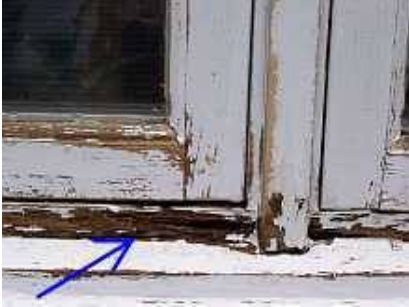
Photo 4-1

One or more window(s) have damage or deterioration and should be repaired or replaced by a qualified contractor.

- One or more window(s) have damage or deterioration and should be repaired or replaced by a qualified contractor.
  - 5

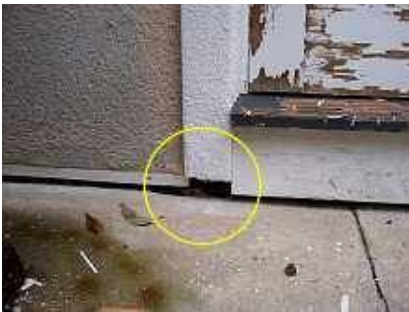
Photo 5-1

One or more wood trim pieces that comes in close contact with the ground or concrete surfaces, has deteriorated and should be repaired or replaced by a qualified contractor.

below french doors at patio

- One or more wood trim pieces that comes in close contact with the ground or concrete surfaces, has deteriorated and should be repaired or replaced by a qualified contractor.

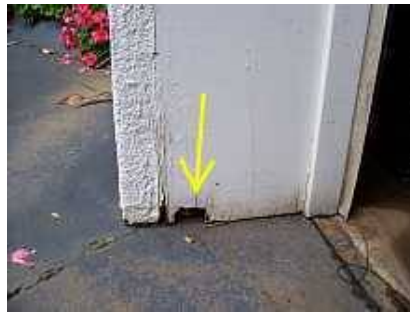
Photo 5-2

wood trim around garage door opening

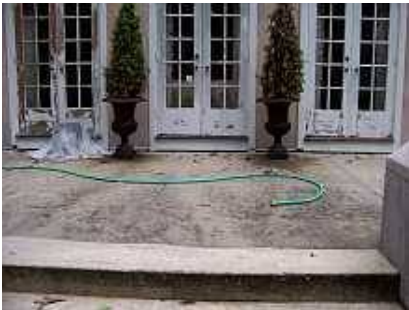
Photo 6-1

The exterior finish on many of the windows and doors is failing. A qualified contractor should prep (pressure wash, scrape, sand, prime caulk, etc.) and repaint or restrain areas as needed and as per standard building practices.

- The exterior finish on many of the windows and doors is failing. A qualified contractor should prep (pressure wash, scrape, sand, prime caulk, etc.) and repaint or restain areas as needed and as per standard building practices.

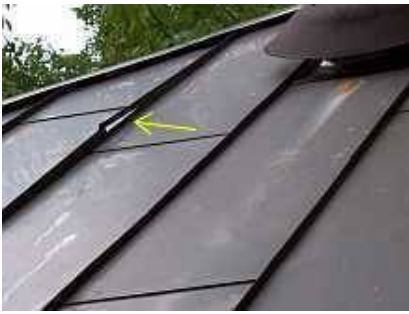
Photo 7-1

One or more metal roof seam covers have come loose and may result in damage to the roof sub-structure. A qualified roofing contractor should make repairs to restore the integrity of the roofing system.

- One or more metal roof seam covers have come loose and may result in damage to the roof sub-structure. A qualified roofing contractor should make repairs to restore the integrity of the roofing system.
-

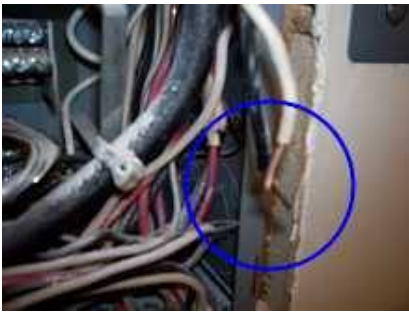
Photo 8-1

One or more loose conductors in the main service panel have bare ends and are not connected to an overcurrent protection device (circuit breakers or fuses). This is a safety hazard due to the risk of fire if the bare conductors come into contact with other components in the panel. A qualified electrician should evaluate and repair as necessary. For example, removing wires that aren't terminated or installing wire nuts.

- One or more loose conductors in the main service panel have bare ends and are not connected to an overcurrent protection device (circuit breakers or fuses). This is a safety hazard due to the risk of fire if the bare conductors come into contact with other components in the panel. A qualified electrician should evaluate and repair as necessary. For example, removing wires that aren't terminated or installing wire nuts.
  - 9

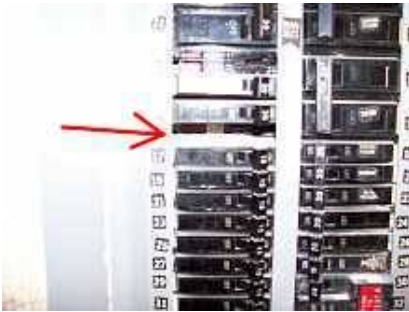
Photo 9-1

One or more knockouts have been removed inside the main service panel where no wires and bushings are installed, and no breaker(s) have been installed to seal the hole(s). This is a safety hazard due to the risk of fire. A qualified electrician should install knockout covers where missing.

- One or more knockouts have been removed inside the main service panel where no wires and bushings are installed, and no breaker(s) have been installed to seal the hole(s). This is a safety hazard due to the risk of fire. A qualified electrician should install knockout covers where missing.
-

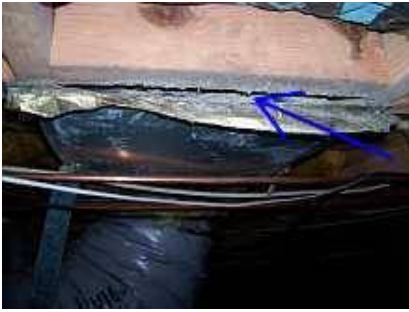
Photo 11-1

A return air opening was found in the crawl space. This situation allows unconditioned air to be drawn into the system, thereby reducing the efficiency and comfort capacity of the system. A qualified heating and cooling contractor should evaluate and make repairs as necessary.

- A return air opening was found in the crawl space. This situation allows unconditioned air to be drawn into the system, thereby reducing the efficiency and comfort capacity of the system. A qualified heating and cooling contractor should evaluate and make repairs as necessary.
  - 12

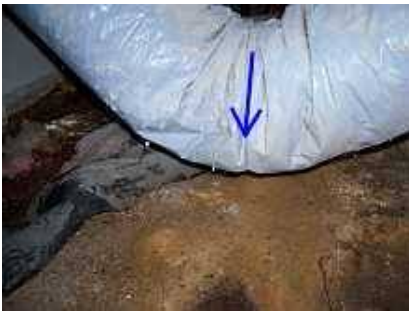
Photo 12-1

One or more sections of flex duct are sagging excessively. The flex duct pictured is below the laundry room area and it also has water trapped inside. Most manufacturers, and the Sheet Metal and Air Conditioning Contractors National Association (SMACNA) recommend that this type of duct sag no more than 1/2" per foot between supports. A qualified heating/cooling contractor should evaluate remove water, and repair as necessary.

- One or more sections of flex duct are sagging excessively. The flex duct pictured is below the laundry room area and it also has water trapped inside. Most manufacturers, and the Sheet Metal and Air Conditioning Contractors National Association (SMACNA) recommend that this type of duct sag no more than 1/2" per foot between supports. A qualified heating/cooling contractor should evaluate remove water, and repair as necessary.
-

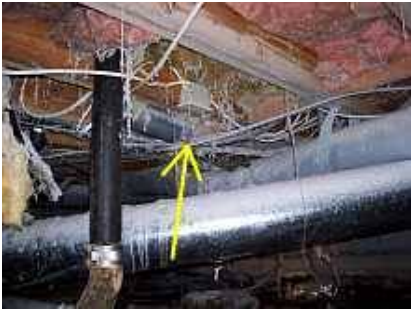
Photo 14-1

The clothes dryer exhaust duct is broken or disconnected in one or more places. Clothes dryers produce large amounts of moisture which should not enter structure interiors. Damage to building components may result. A qualified contractor should evaluate and make permanent repairs as necessary. For more information, visit <http://www.cpsc.gov/CPSCPUB/PUBS/5022.html>

- The clothes dryer exhaust duct is broken or disconnected in one or more places. Clothes dryers produce large amounts of moisture which should not enter structure interiors. Damage to building components may result. A qualified contractor should evaluate and make permanent repairs as necessary. For more information, visit <http://www.cpsc.gov/CPSCPUB/PUBS/5022.html>

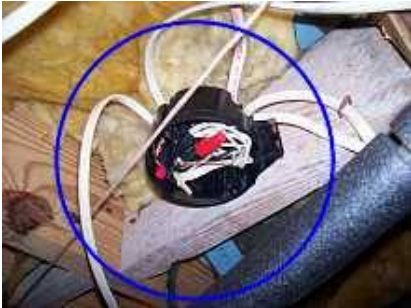
Photo 15-1

- 15) 🚨🔧 Cover plate(s) are missing from one or more electric boxes, such as for receptacles, switches and/or junction boxes. They are intended to contain fire and prevent electric shock from exposed wires. This is a safety hazard due to the risk of fire and shock. Cover plates should be installed where missing.

- Cover plate(s) are missing from one or more electric boxes, such as for receptacles, switches and/or junction boxes. They are intended to contain fire and prevent electric shock from exposed wires. This is a safety hazard due to the risk of fire and shock. Cover plates should be installed where missing.

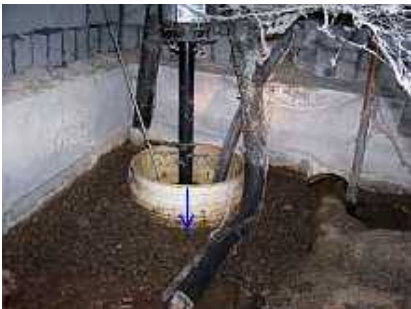
Photo 16-1

- 16) 🔧🔍📄 The inspector was unable to test the sump pump for one or more reasons (no source of water, appeared unsafe, no power, etc.). The sump pump well or "bucket" is not set low enough for water to flow into it. A qualified plumber should evaluate and position the container to remove unwanted water as quickly as possible once it has entered the crawlspace. The sump pump was not fully evaluated.

- The inspector was unable to test the sump pump for one or more reasons (no source of water, appeared unsafe, no power, etc.). The sump pump well or "bucket" is not set low enough for water to flow into it. A qualified plumber should evaluate and position the container to remove unwanted water as quickly as possible once it has entered the crawl space. The sump pump was not fully evaluated.

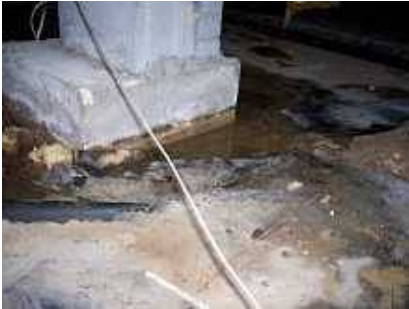
Photo 17-1

Standing water was found in one or more sections of the crawl space. Accumulated water is a conducive condition for wood destroying insects and organisms and should not be present in the crawl space. A qualified contractor who specializes in drainage issues should evaluate and repair as necessary. Typical repairs for preventing water from accumulating in crawl spaces include:

- Standing water was found in one or more sections of the crawl space. Accumulated water is a conducive condition for wood destroying insects and organisms and should not be present in the crawl space. A qualified contractor who specializes in drainage issues should evaluate and repair as necessary. Typical repairs for preventing water from accumulating in crawl spaces include:

- Repairing, installing or improving rain run-off systems (gutters, downspouts and extensions or drain lines)
- Improving perimeter grading
- Repairing, installing or improving underground footing and/or curtain drains

Ideally, water should not enter crawl spaces, but if water must be controlled after it enters the crawl space, then typical repairs include installing trenches, drains and/or sump pump(s) in the crawl space.

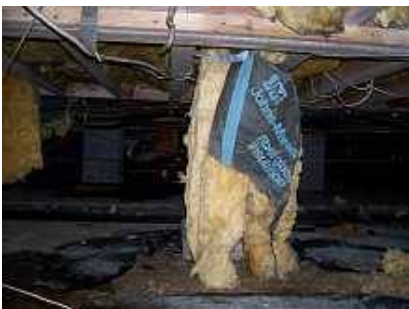
Photo 18-1

Insulation under the floor in the crawlspace is damaged, deteriorated, or has fallen down. A qualified contractor should make repairs as necessary to restore the insulation to its original rating.

- Insulation under the floor in the crawlspace is damaged, deteriorated, or has fallen down. A qualified contractor should make repairs as necessary to restore the insulation to its original rating.

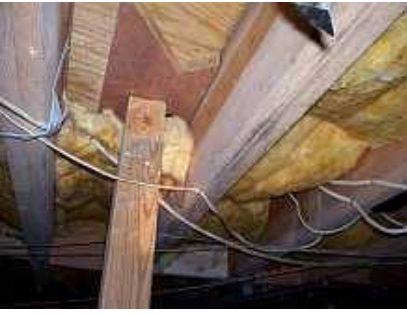
Photo 19-1

A 4"x4" support post in the crawl space is positioned improperly and may cause the sub-floor to separate from the floor joist. A qualified contractor should evaluate the purpose for the additional support and correctly position it under the floor joist if it is necessary for support.

- A 4"x4" support post in the crawl space is positioned improperly and may cause the sub-floor to separate from the floor joist. A qualified contractor should evaluate the purpose for the additional support and correctly position it under the floor joist if it is necessary for support.

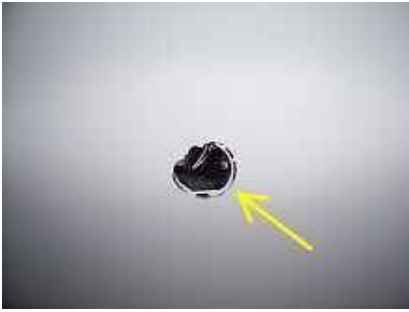
**Photo 25-1**

Cover plate(s) are missing from one or more electric boxes, such as for receptacles, switches and/or junction boxes. They are intended to contain fire and prevent electric shock from exposed wires. This is a safety hazard due to the risk of fire and shock. Cover plates should be installed where missing.

- Cover plate(s) are missing from one or more electric boxes, such as for receptacles, switches and/or junction boxes. They are intended to contain fire and prevent electric shock from exposed wires. This is a safety hazard due to the risk of fire and shock.

Cover plates should be installed where missing.

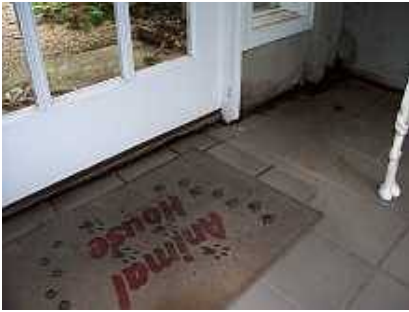
**Photo 27-1**

Ground water is seeping into the floor of the garage to house connector room. Water in contact with wood surfaces causes swelling, deterioration, discoloring, and damp musty odor. Water intrusion should be addressed first and then repairs to damaged wood should be completed.

- Ground water is seeping into the floor of the garage to house connector room. Water in contact with wood surfaces causes swelling, deterioration, discoloring, and damp musty odor. Water intrusion should be addressed first and then repairs to damaged wood should be completed.
- 28**
